MEMORANDUM

To:	Gary Miller and Anne Foster U.S. Environmental Protection Agency	Date:	August 14, 2015
From:	John Laplante, John Verduin, Wendell Mears, and David Keith, Anchor QEA	Project:	090557-01
Cc:	Phil Slowiak, IP David Moreira, MIMC		
Re:	Post-TCRA Semi-Annual Inspection Report – July 2015

This document reports the results of the July 2015 inspection of the armored cap cover, fencing, and signage installed for the Time Critical Removal Action (TCRA) at the San Jacinto River Waste Pits Superfund Site (TCRA Site).

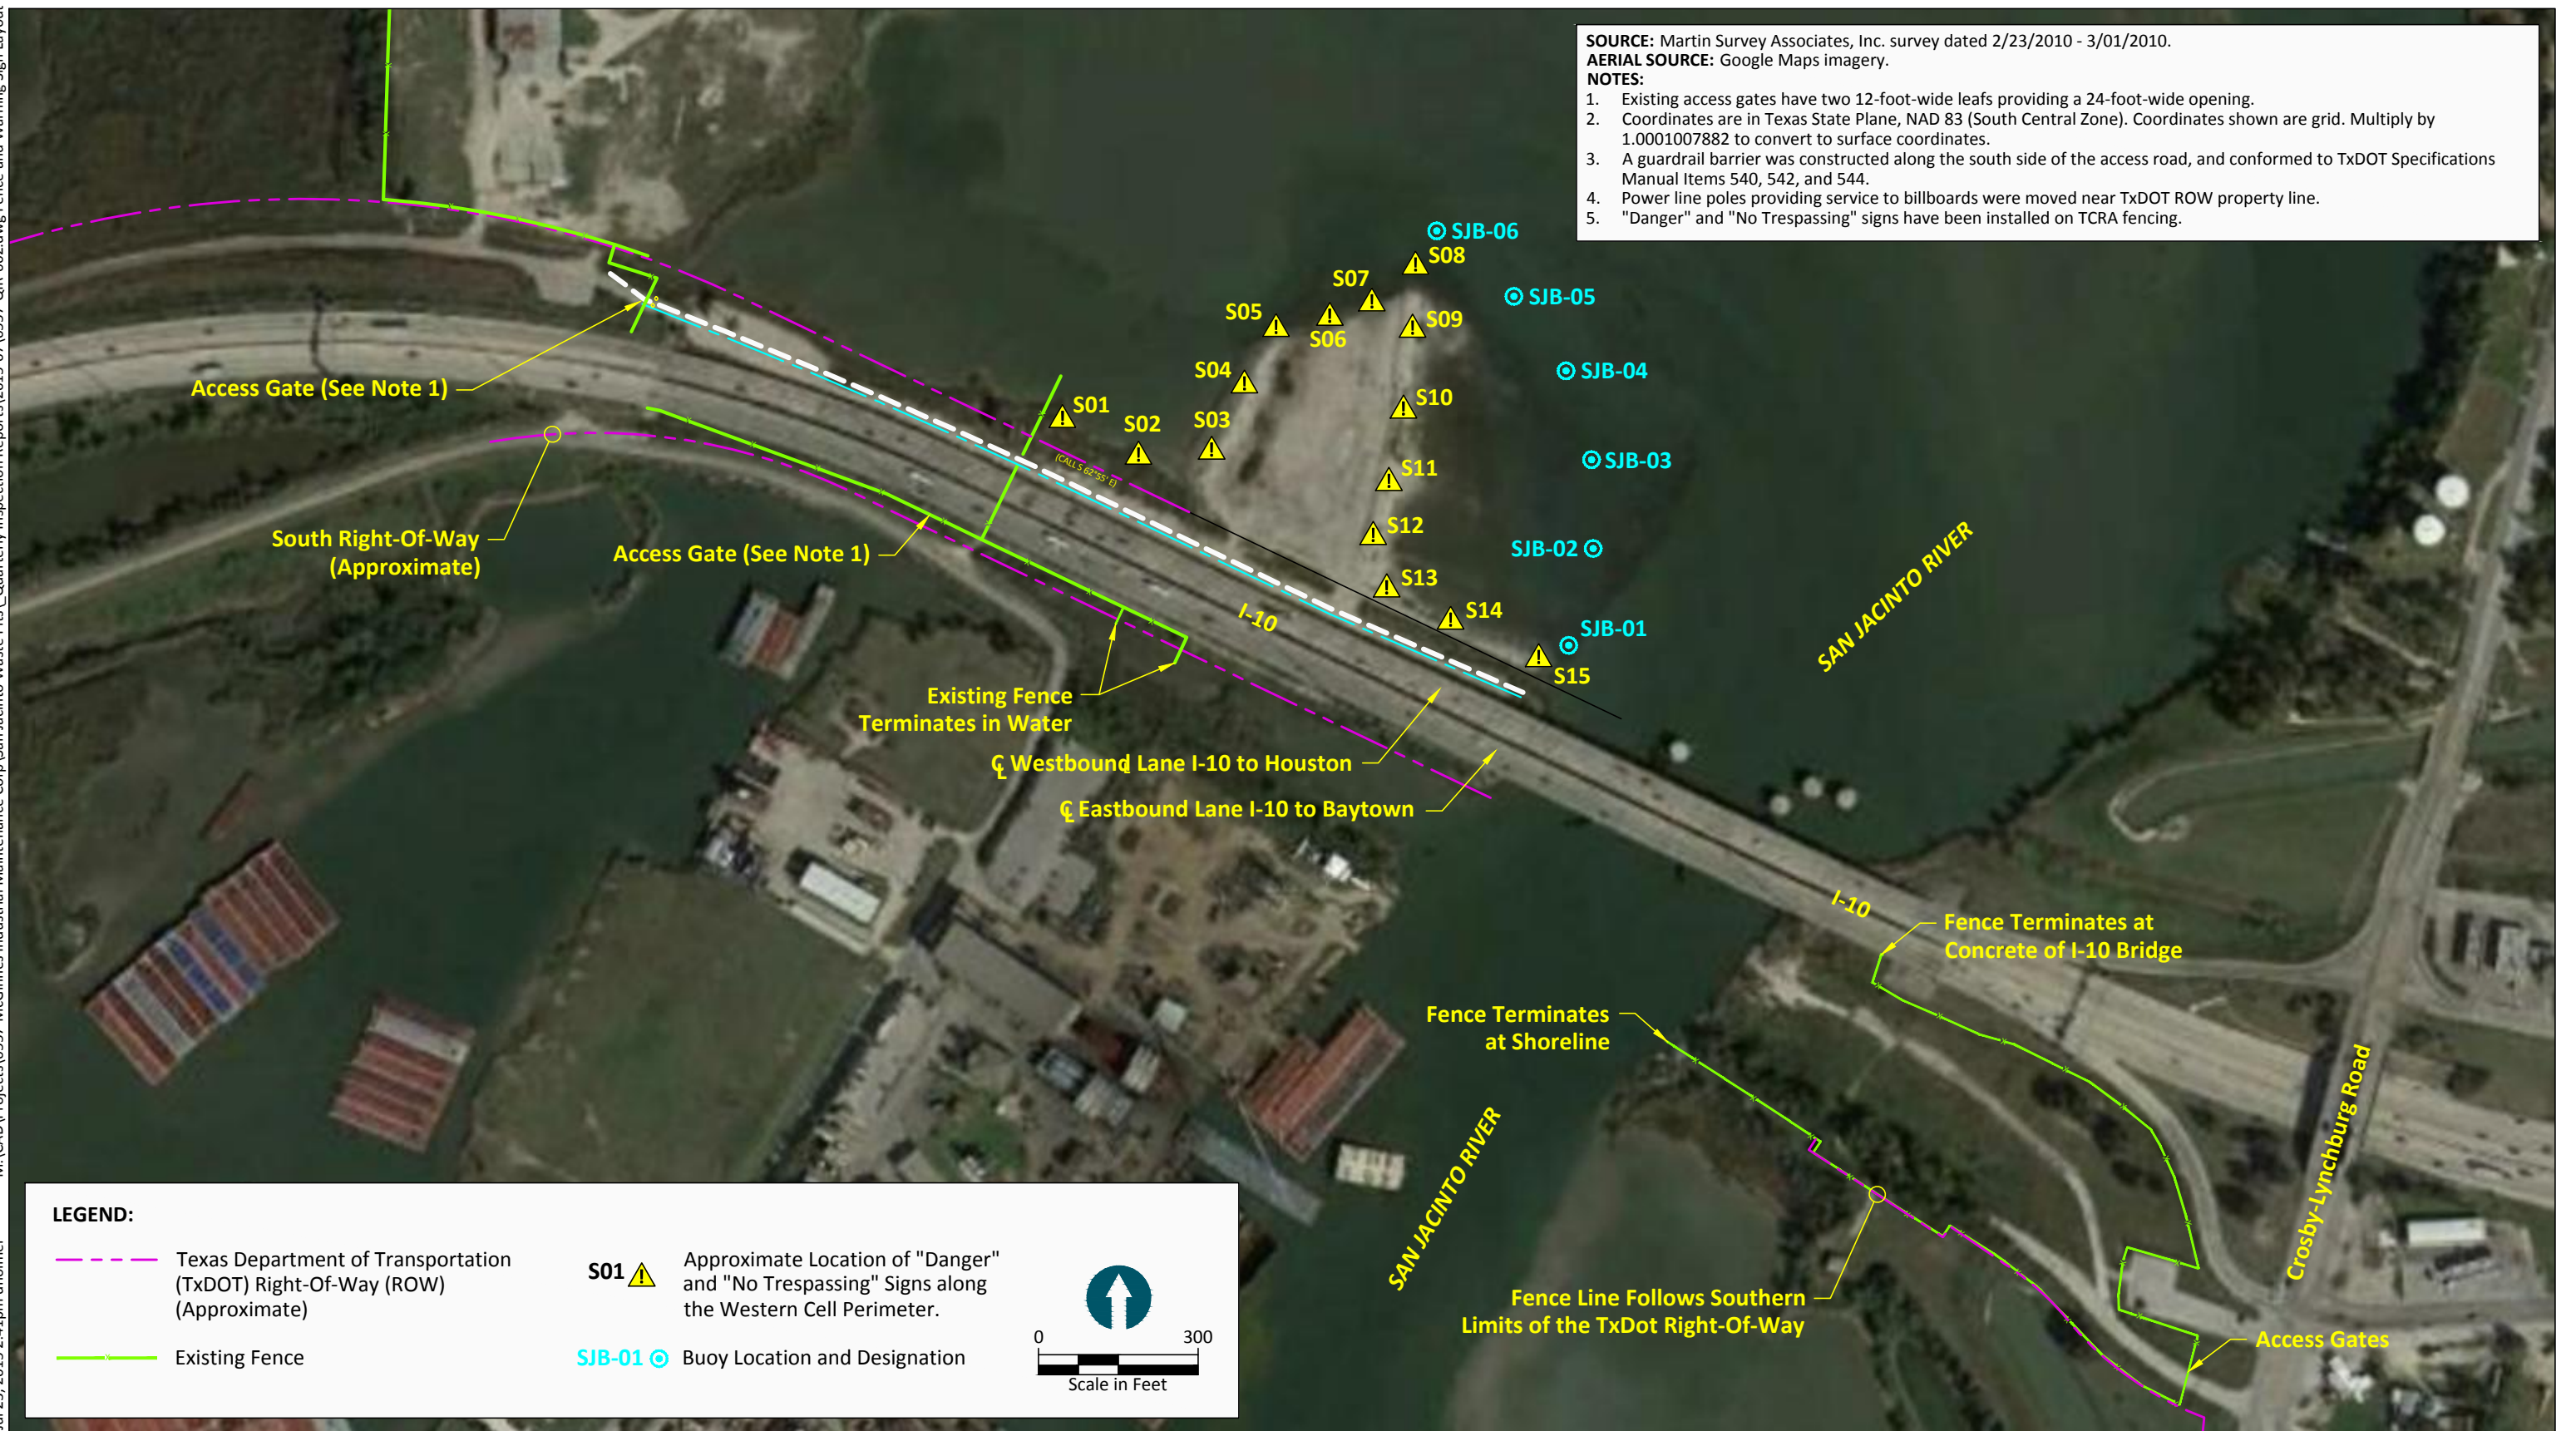
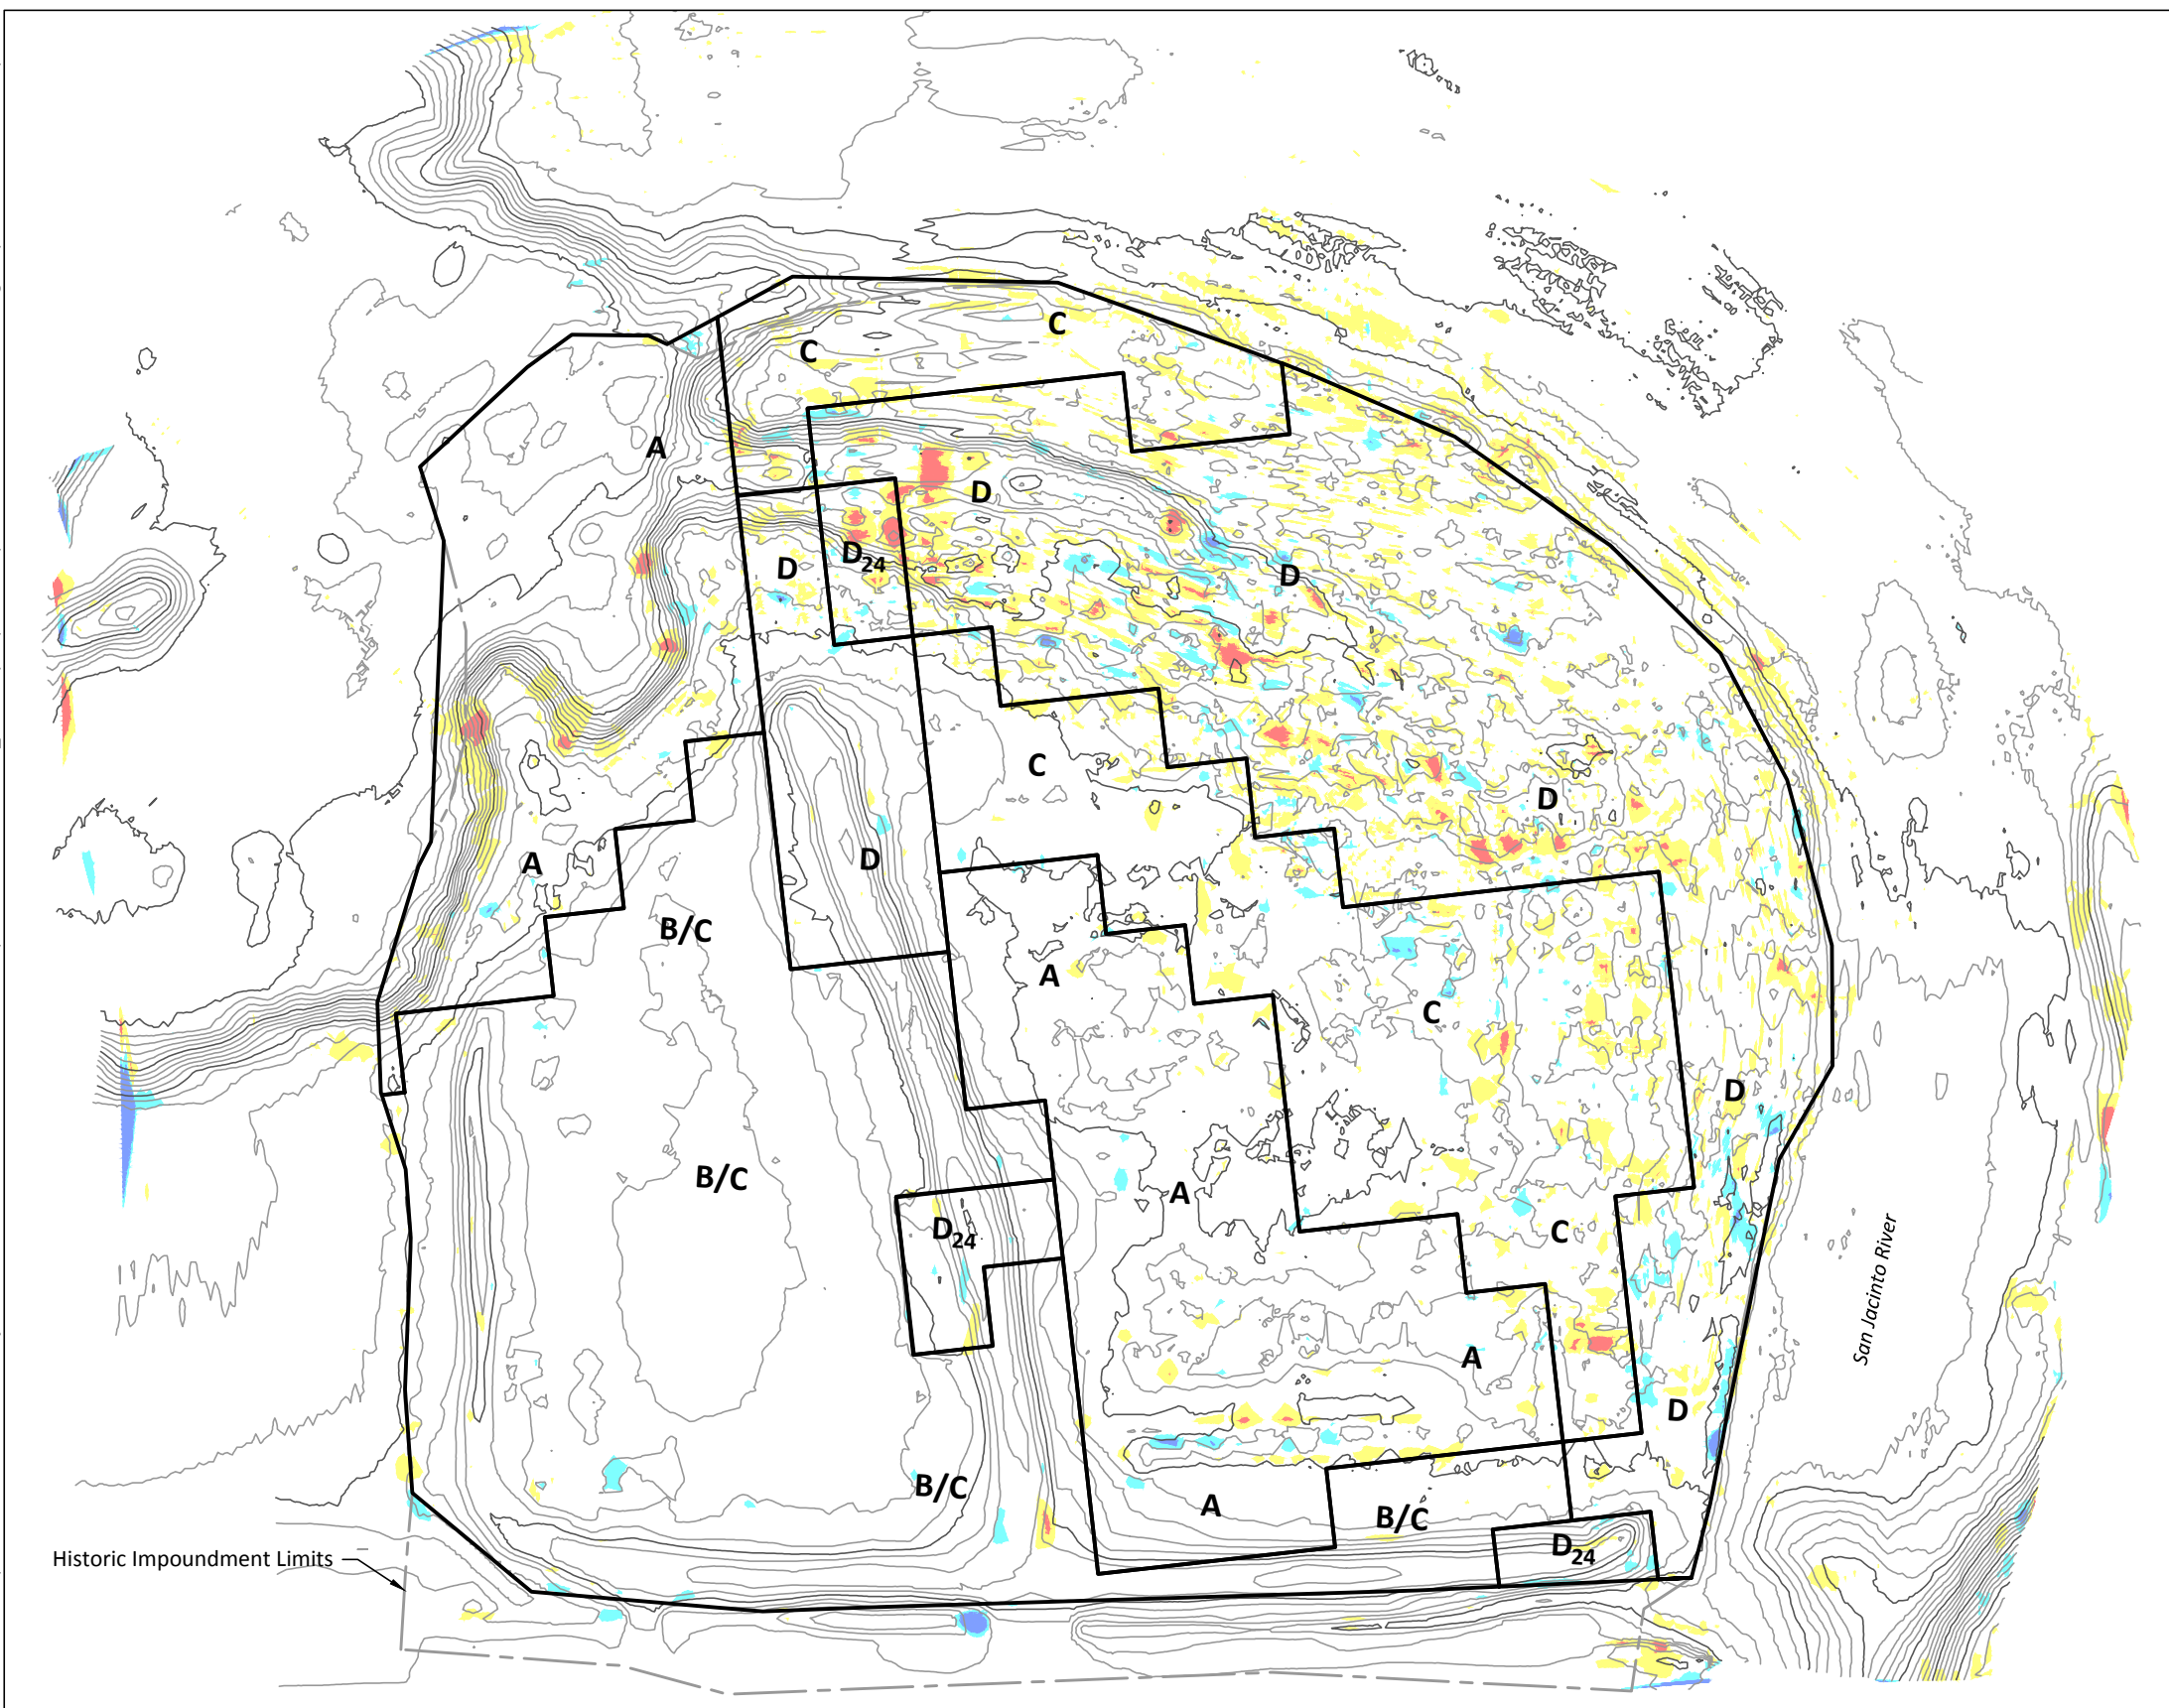
The survey data from the July 2015 inspection survey and the January and April 2015 surveys were compared to evaluate the differences in the top of the armored cap elevation. These differences are shaded and shown on Figure 3. The survey results indicate continued sedimentation/deposition on the surface of the armored cap in submerged areas.

Manual probing of armored cap thickness is required at areas identified by the topographic or bathymetric surveys as more than 6 inches lower in elevation than during the prior survey over contiguous areas of 30 feet by 30 feet. When the July 2015 and prior January and April 2015 surveys were compared, the results indicated that there were no areas that met the manual probing requirement. Therefore, no probing was conducted as part of the July 2015 inspection.

The small areas identified as increases and decreases in elevation can be attributed to the horizontal and vertical limitations of the survey, minor shifts in track line location from the baseline survey, and elevation data recorded in the crevices between rock surfaces or atop

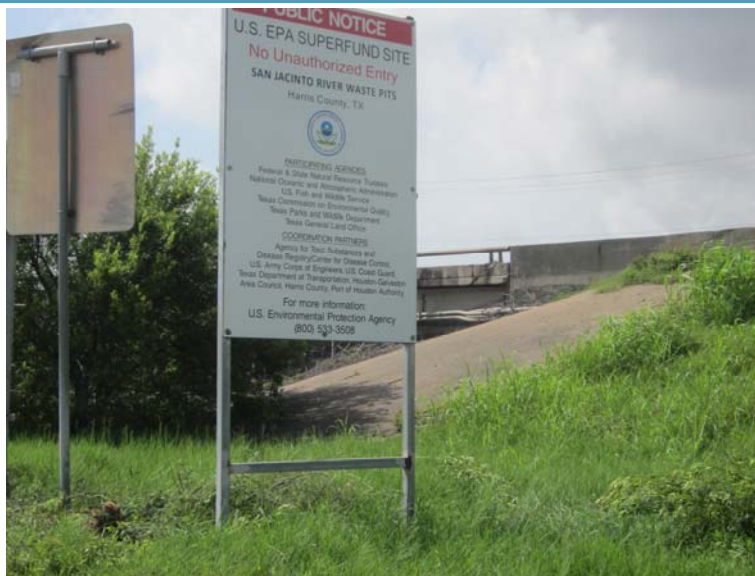
Three USEPA Public Notice signs are present around the TCRA Site located: 1) near the gate entry point for the perimeter fence north of I-10; 2) near a gate entry point south of I-10; and 3) at the end of the TxDOT right-of-way north of I-10 near the San Jacinto River. For examples, see Photographs 1 and 11 in Appendix A. These three signs were observed to be in place and undamaged. Vegetation growing in front of the signs was cut down on July 1, 2015 and herbicide was applied on July 9 and 22, 2015 to prevent possible obstructions.

Photograph 01: USEPA Public Notice Sign located outside the access gate north of I-10 (view southeast)

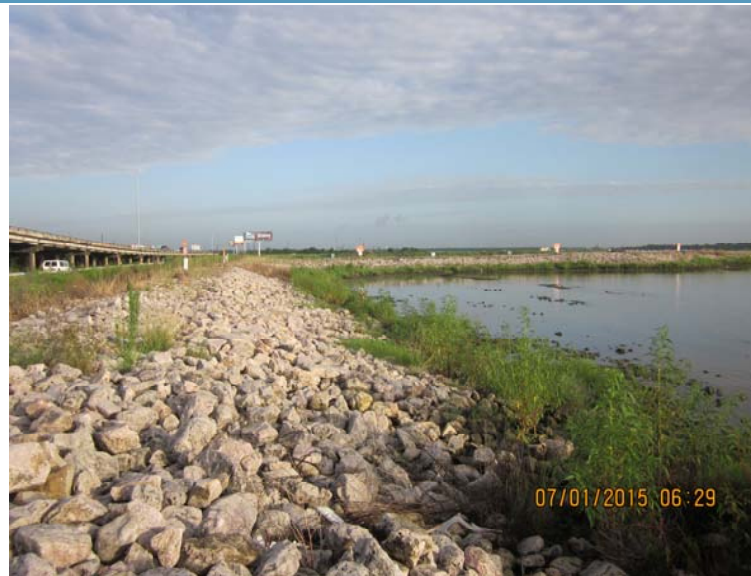
Photographs of the armored cap from the inspection event are provided in Appendix A (see Photographs 2 through 8). Due to higher water levels, the majority of the Eastern Cell armored cap was underwater. All of the visible portions of the armored cap were observed to be intact, and no movement of cap materials was observed at any location during the visual inspection.

Photograph 02: Southern berm (view west)

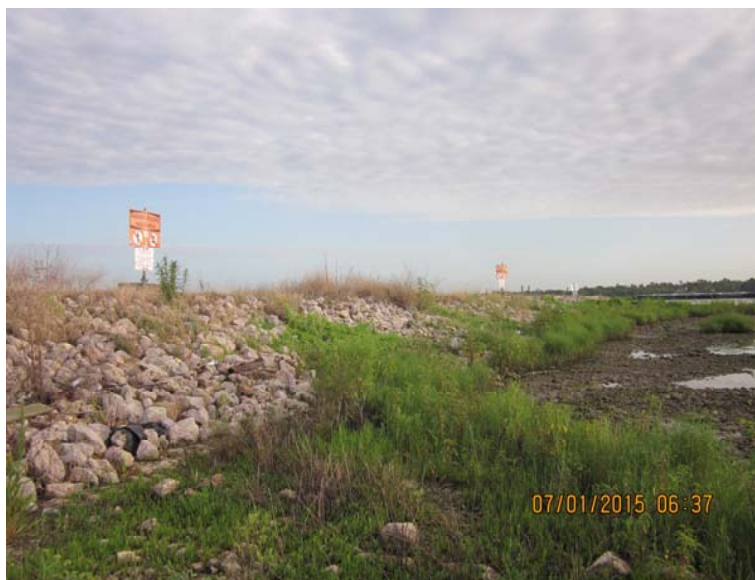
Photograph 03: Central berm and intertidal area of Eastern Cell (view northwest)

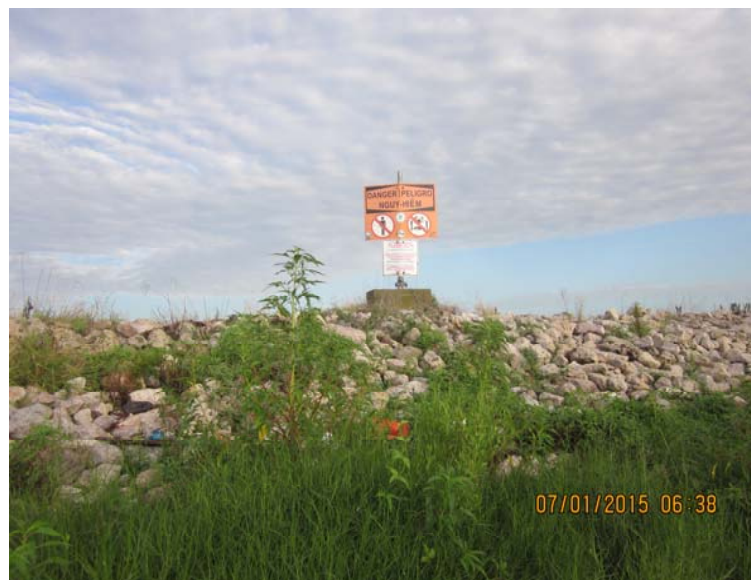
A total of fifteen signs were installed at the TCRA Site around the perimeter of the land portion of the TCRA Site; the signs are mounted on steel posts and set in concrete pads. For examples, see Photographs 3 and 4 in Appendix A. These signs are intended to face the San Jacinto River to deter water-based entry to the TCRA Site. A few of these signs had rotated out of proper alignment due to the wind; the affected signs were re-aligned to the intended viewing perspective.

Photograph 04: Warning sign along central berm (view west)

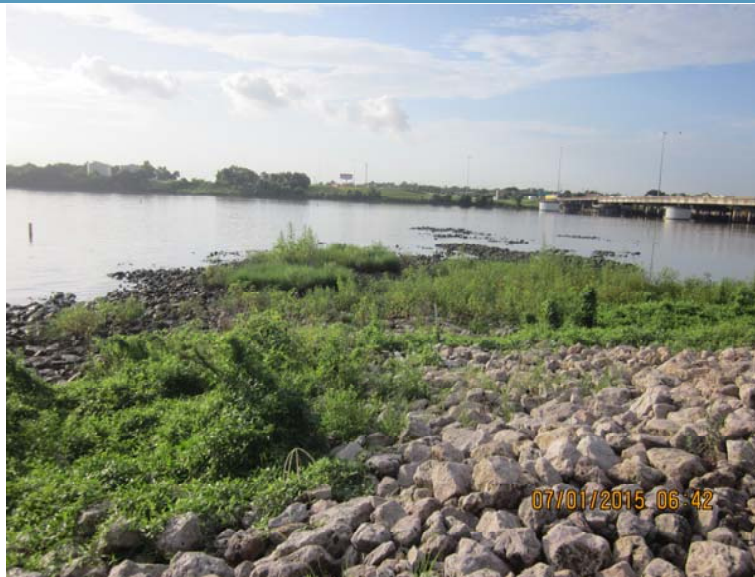
Grassy and woody vegetation was observed around much of the armored cap perimeter during the July 1, 2015 visual inspection due to the large amounts of rainfall earlier in the summer. Vegetative control via herbicide took place on July 9, 2015. On July 16, 2015, a follow-up visit to the site identified areas where a second application was needed (see Photographs 19 and 20). Photographs 21 and 22 from July 22, 2015 show the progress of the initial herbicide treatment and state of the vegetation prior to the second application that was completed the same day.

Photograph 05: Vegetation along intertidal area of Eastern Cell (view southeast)

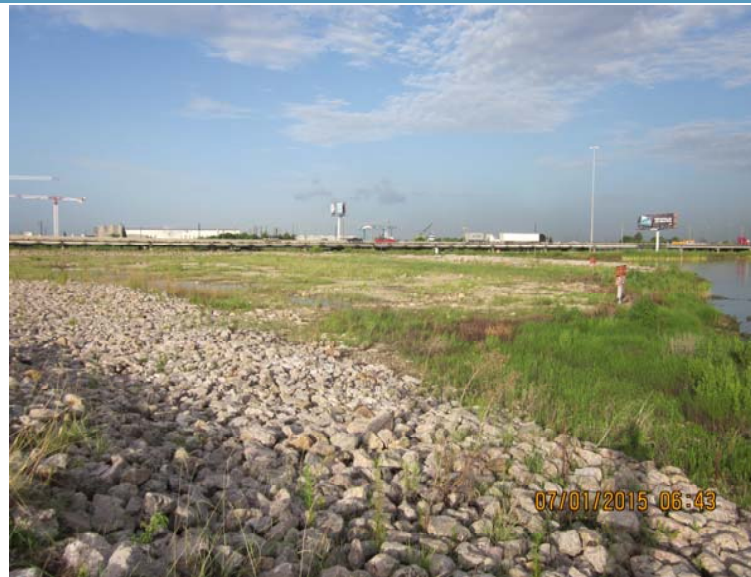
Photograph 06: Interior or Western Cell (view southwest)

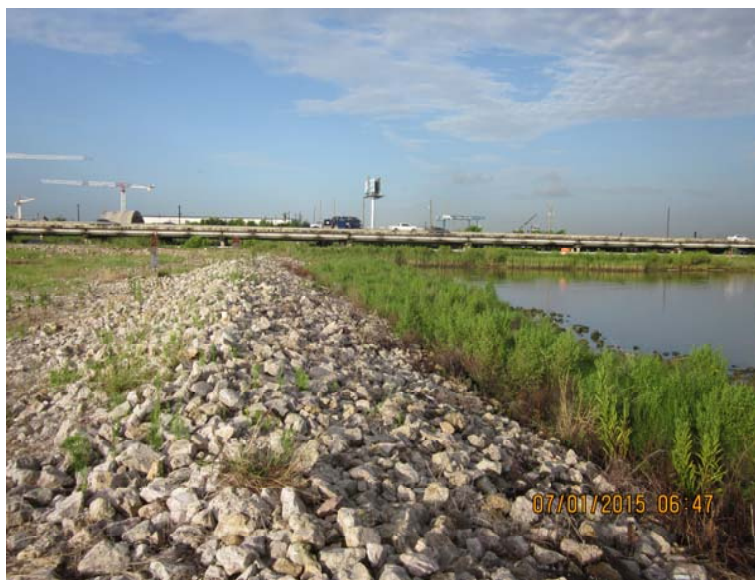
Photograph 07: Western berm (view south)

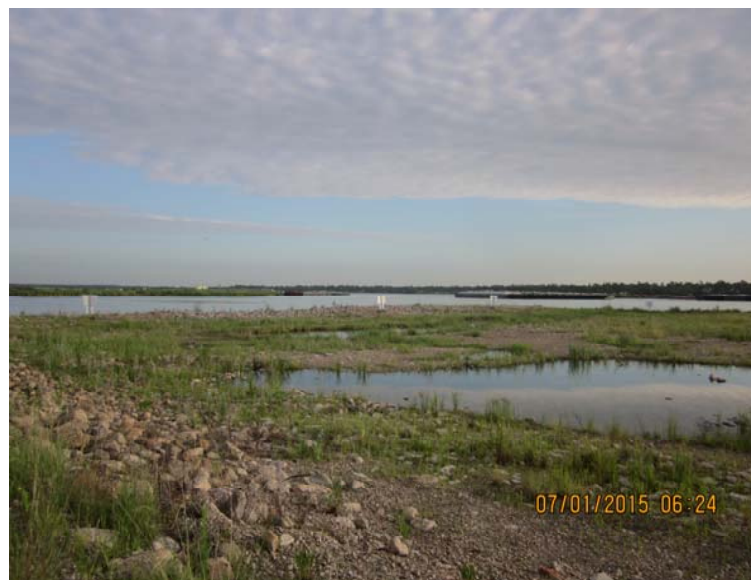
Photograph 08: Interior of Western Cell (view northwest)

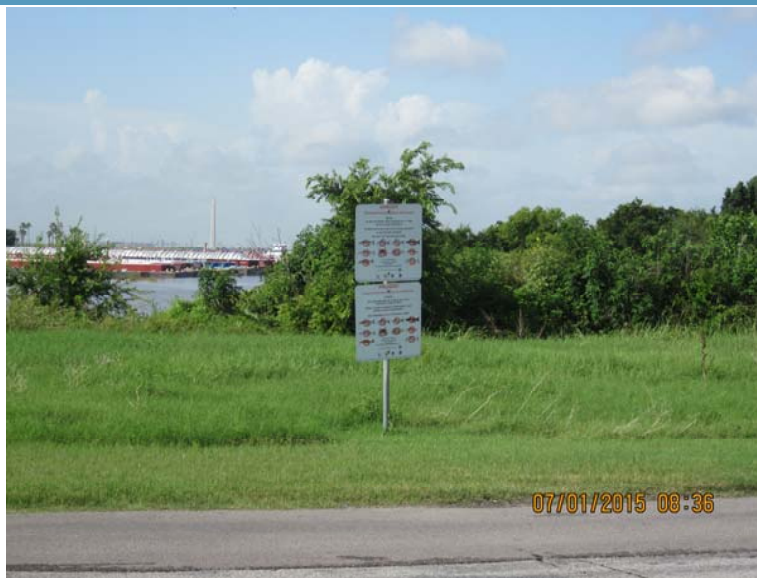
Photograph 09: Fish consumption advisory signs located south of I-10 on west bank (view south)

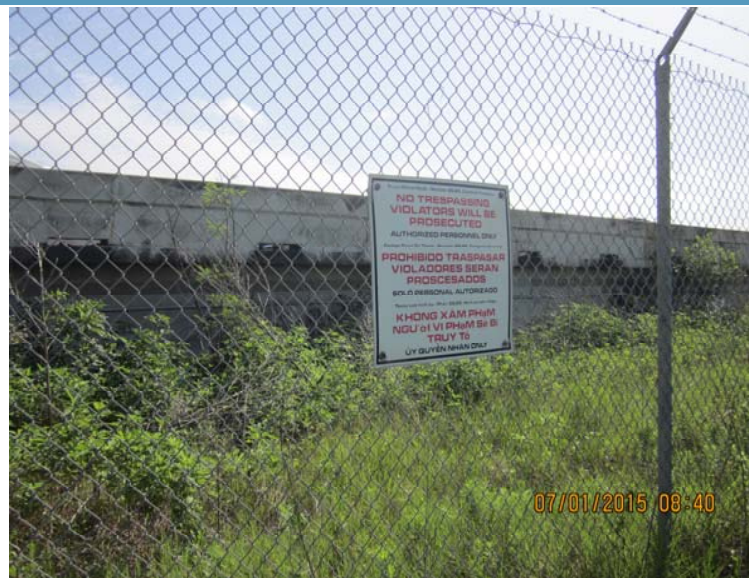
The perimeter fencing on the west and east banks of the San Jacinto River was visually inspected for breaches or other signs of damage. No breaches or other signs of fence damage were observed during the inspection for any of the three sections of the fence: the east bank, the west bank on the north side of I-10, or the west bank on the south side of I-10. For examples, see Photographs 10 through 14 in Appendix A.

"Danger" and "No Trespassing" signs are posted at regular intervals on the perimeter fencing surrounding the TCRA Site. For examples, see Photographs 10 and 13 in Appendix A. These signs were observed to be in place during the July 1, 2015 inspection.

Photograph 10: Warning sign on perimeter fencing south of I-10 on west bank (view northeast)

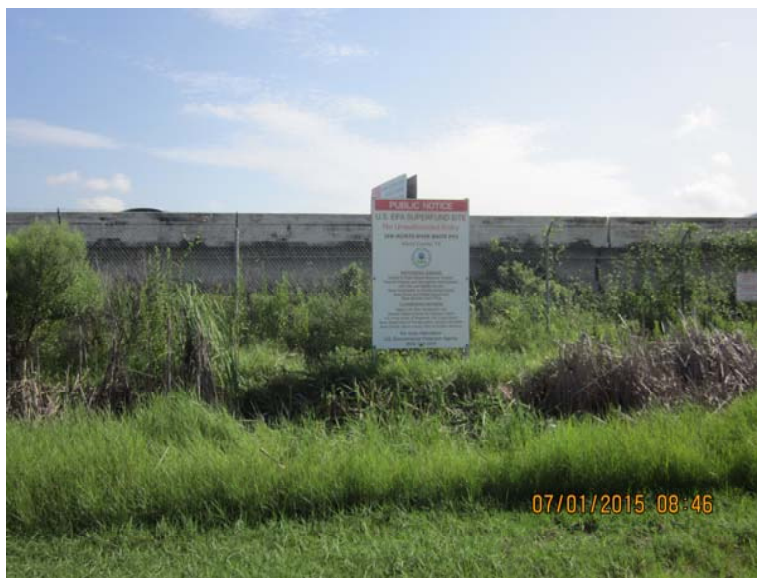
Photograph 11: USEPA Public Notice Sign located south of I-10 on west bank (view north)

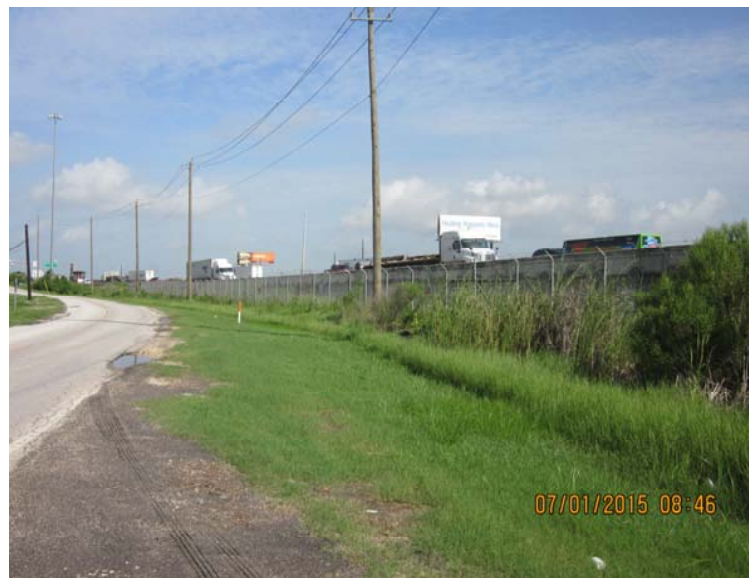
Photograph 12: Perimeter fencing south of I-10 on west bank (view northwest)

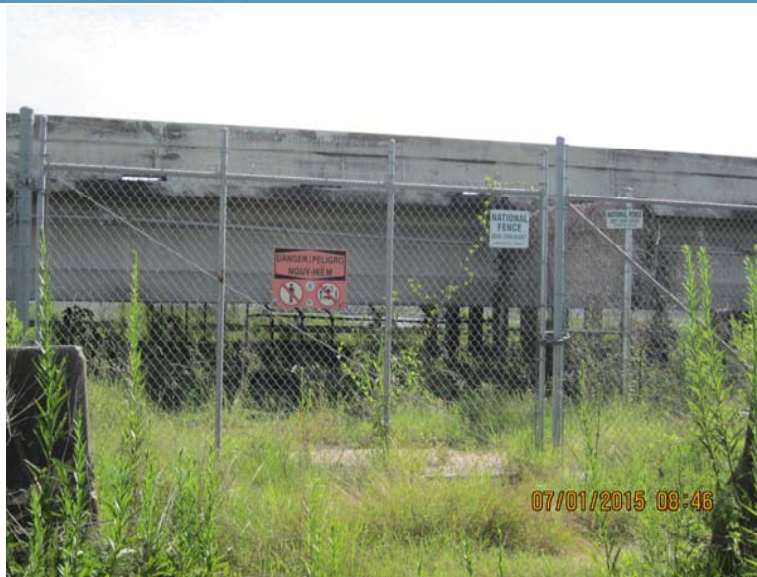
Photograph 13: Warning sign on perimeter fencing south of I-10 on west bank (view north)

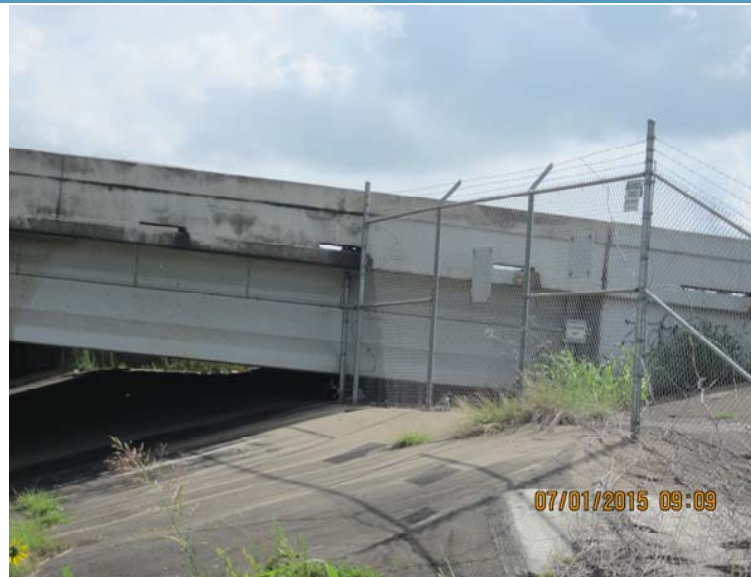
Photograph 14: Perimeter fencing south of and adjacent to I-10 on east bank (view northeast)

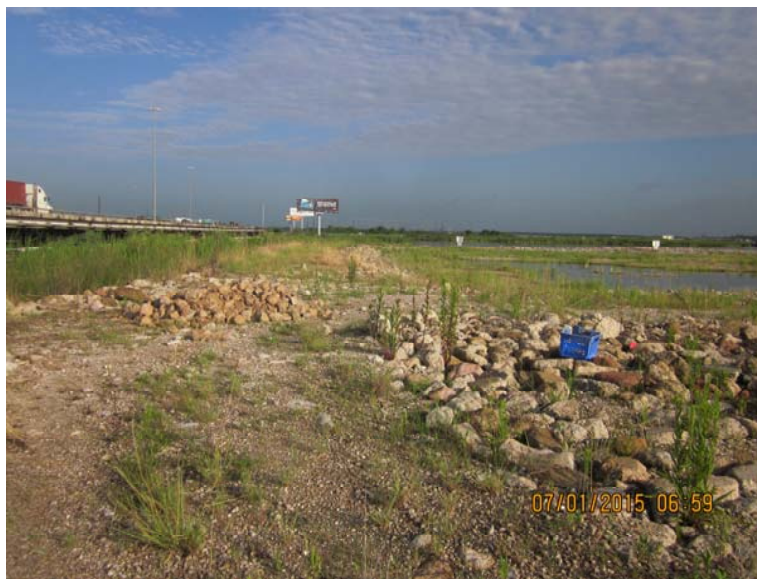
During a site visit on June 6, 2015, exposed geotextile in a small area near the intersection of the southern and central berms in the stockpile area was observed. A subsequent investigation found that the exposed area was a third layer of geotextile that was applied as

Photograph 15: Stockpile material and area with exposed 3rd layer geotextile near intersection of southern and central berms (view west)

extra protection in the stockpile area during construction activities. With USEPA's concurrence, on July 1, 2015, the Respondents manually placed armor cap material over the exposed third layer of geotextile (see Photographs 15 through 18). A stockpile of armor cap material is located by the access ramp to the central berm in the event it is needed for minor repairs or other purposes.

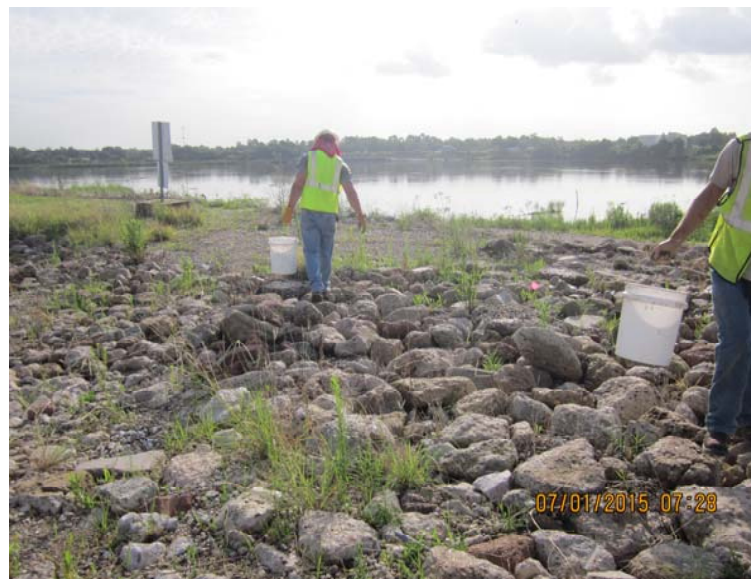
Photograph 16: Benchmark manually adding material to cover exposed 3rd layer geotextile near intersection of southern and central berms (view northeast)

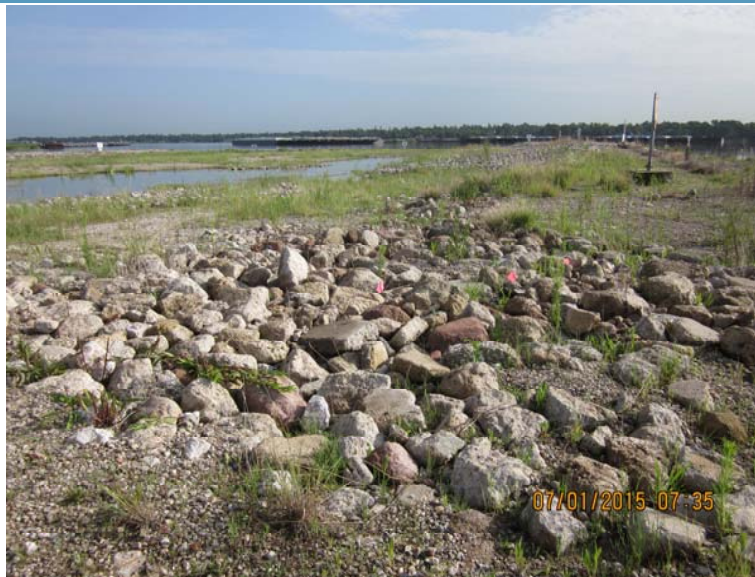
Photograph 17: Manually repaired area with previously exposed 3rd layer geotextile near intersection of southern and central berms (view northwest)

Respondents added additional rock in the stockpile area to cover small exposed geotextile areas there and conducted vegetation control. No TCRA construction elements were identified as deficient or damaged during this inspection event. No maintenance was required to the TCRA cap in response to the July 2015 inspection.

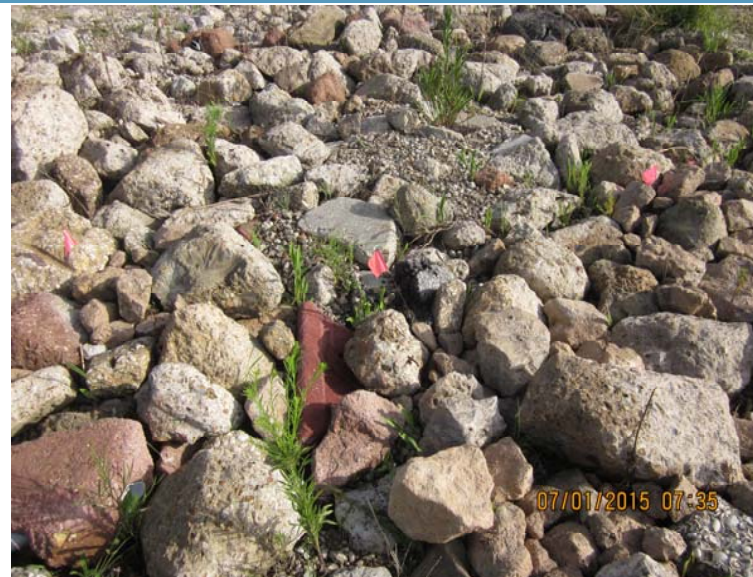
Photograph 18: Close-up of repaired area shown in Photograph 17

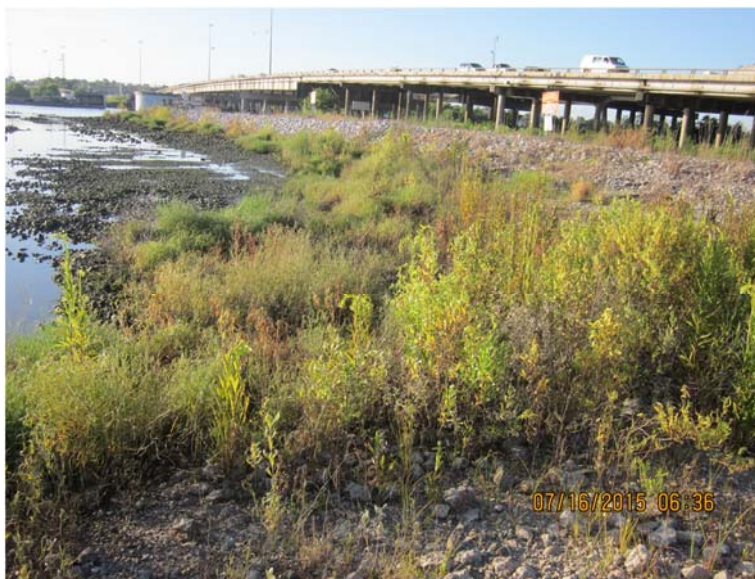
Photograph 19: Vegetation at intersection of southern and central berms one week after initial vegetative control measures (view southeast)

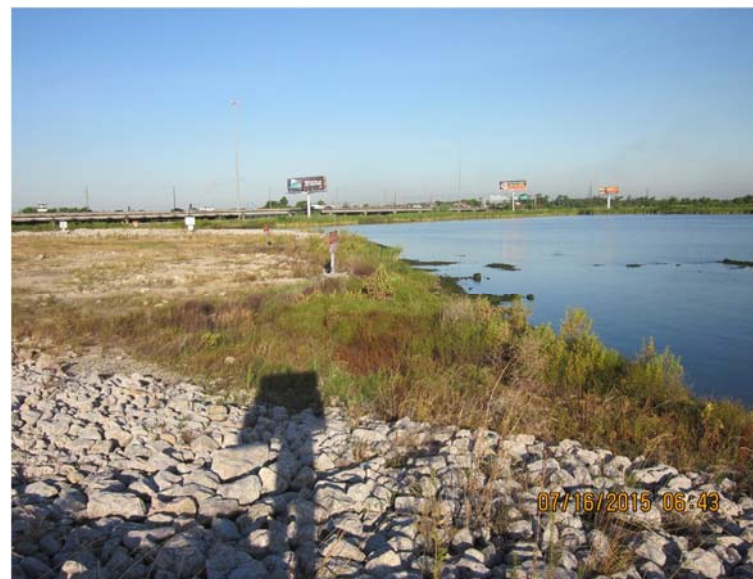
Photograph 20: Vegetation on northern edge of Western Cell one week after initial vegetative control measures (view southwest)

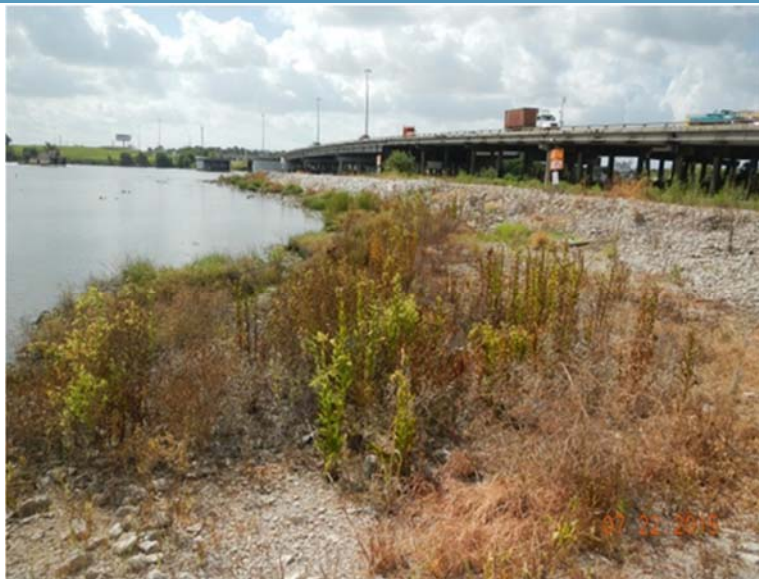
Photograph 21: Vegetation at intersection of southern and central berms prior to second application of vegetative control measures (view southeast)

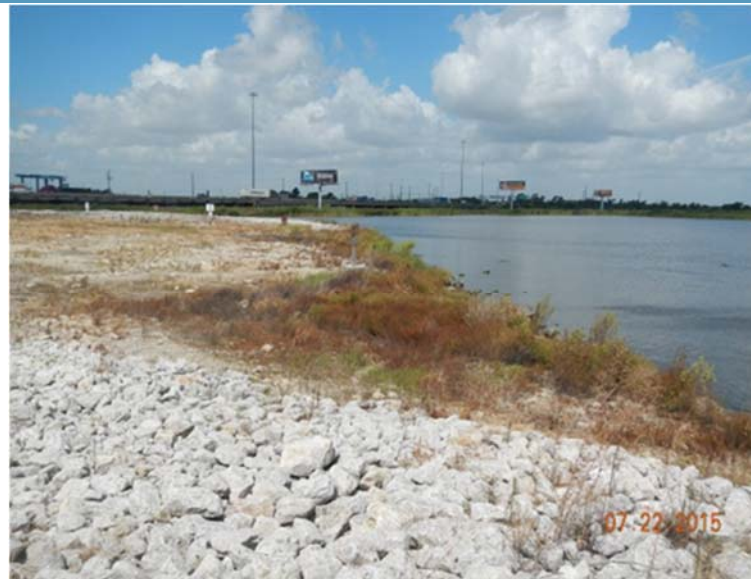
Photograph 22: Vegetation on northern edge of Western Cell prior to second application of vegetative control measures (view southwest)
